Technical Report

No. 13509

THE DESIGN, DEVELOPMENT AND FABRICATION
OF AN ORGANIC COMPOSITE SHIPPING CONTAINER
FOR THE FULL UP POWER PACK (FUPP) (U)

APRIL 1990

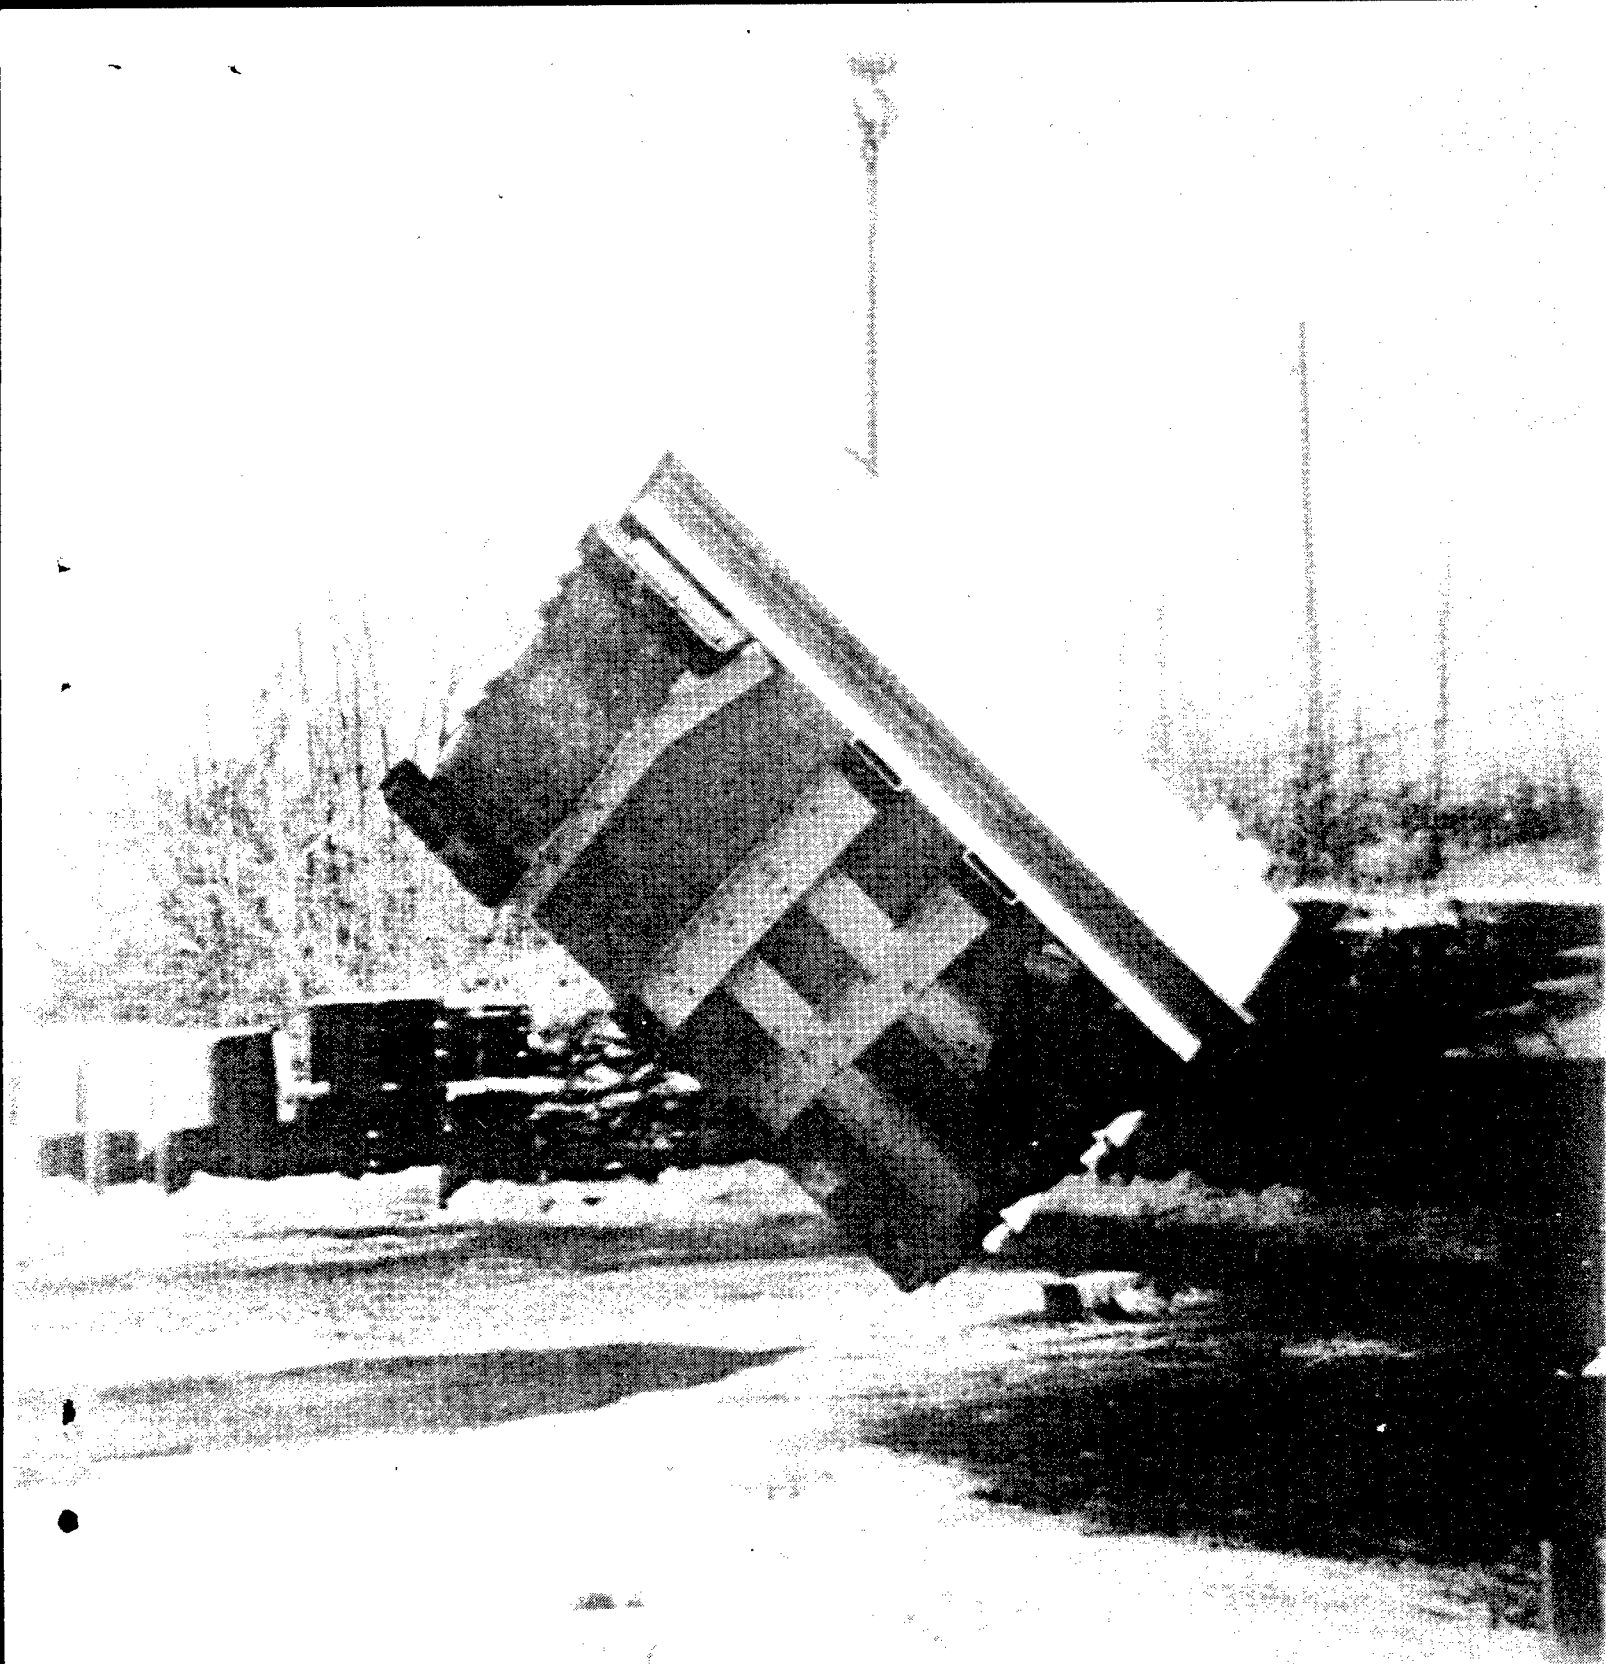
HOISING TEST

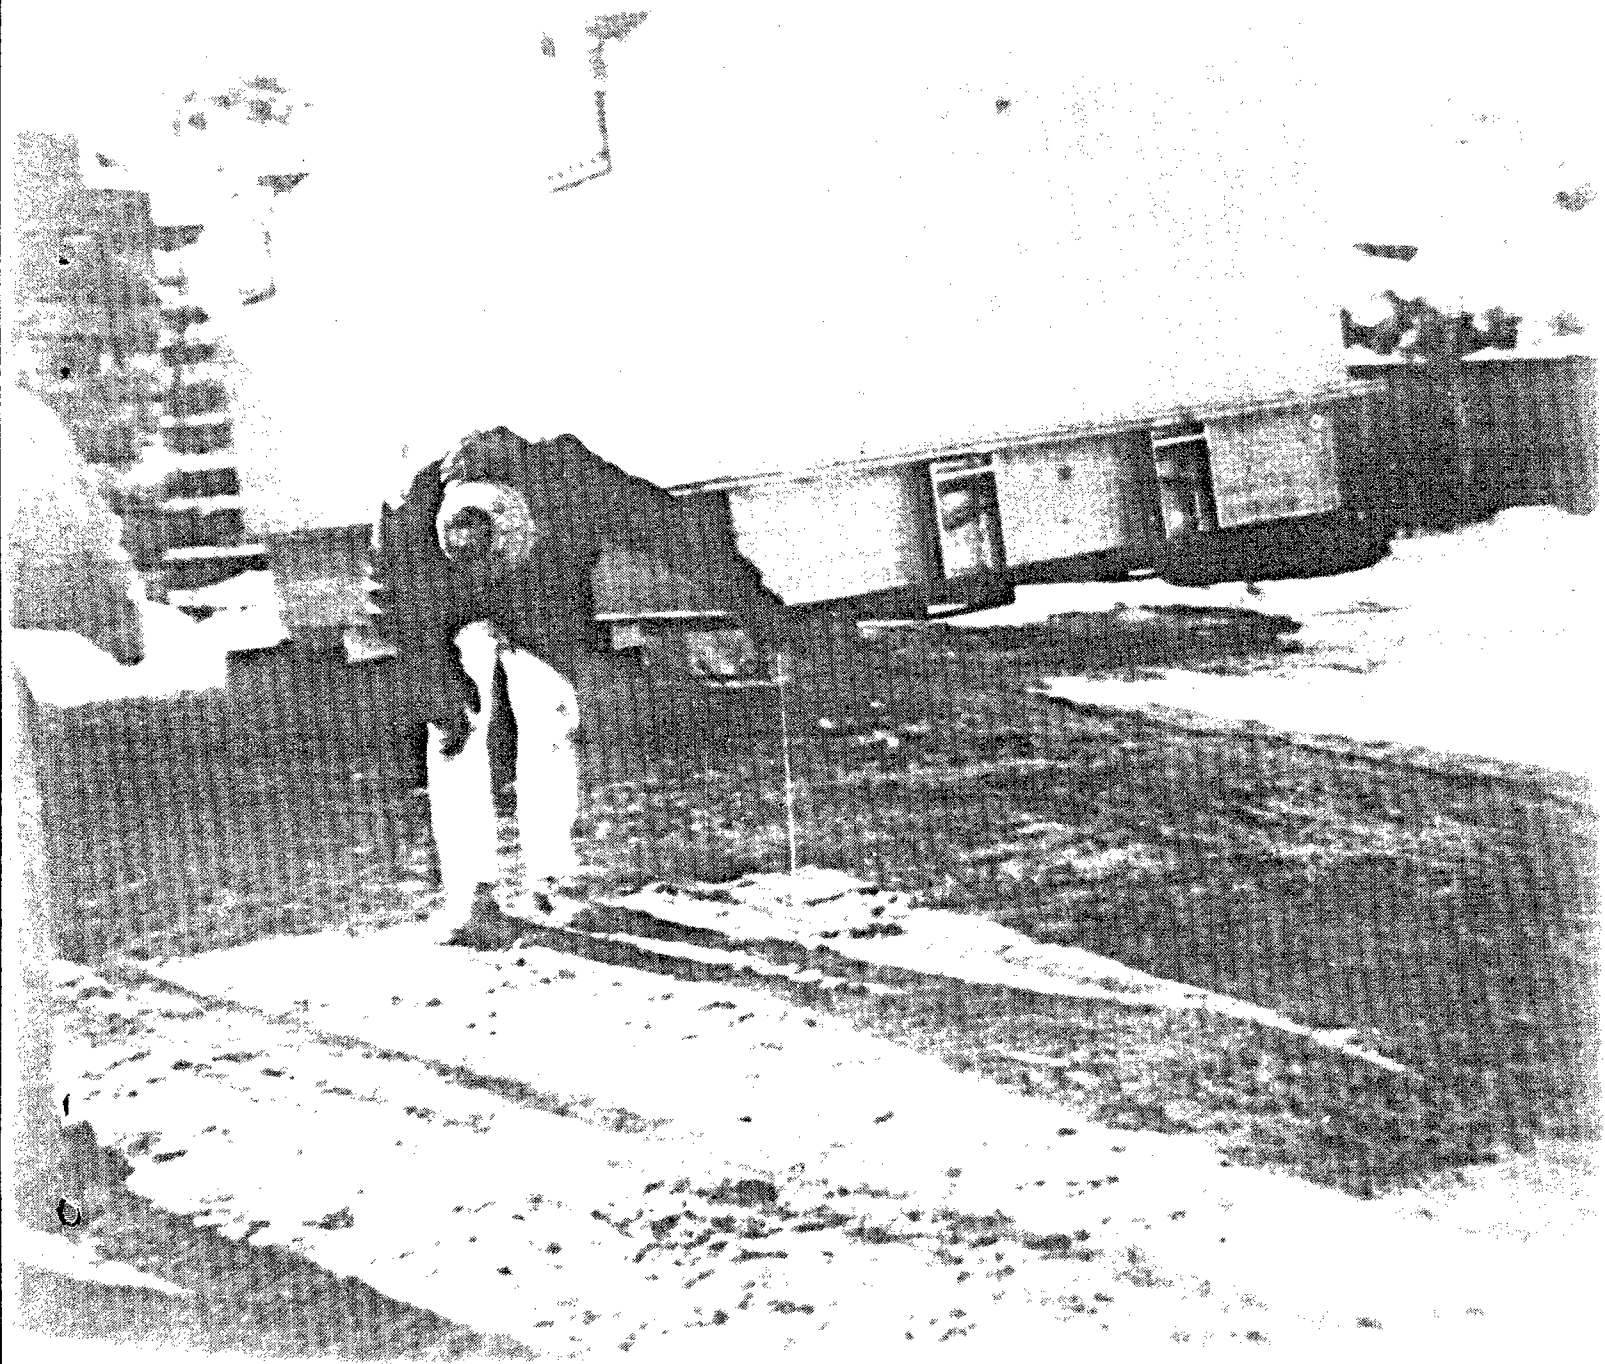
EDGEWISE DROP TEST (AFT END)
